EMPATH Bearing Detection Case Study

Bearing and winding failures due to harmonic and ground conditions in the motor and circuit.

300 horsepower, 1765 RPM, 6318ZZ bearings
40 Rotor Bars, 48 Stator Slots

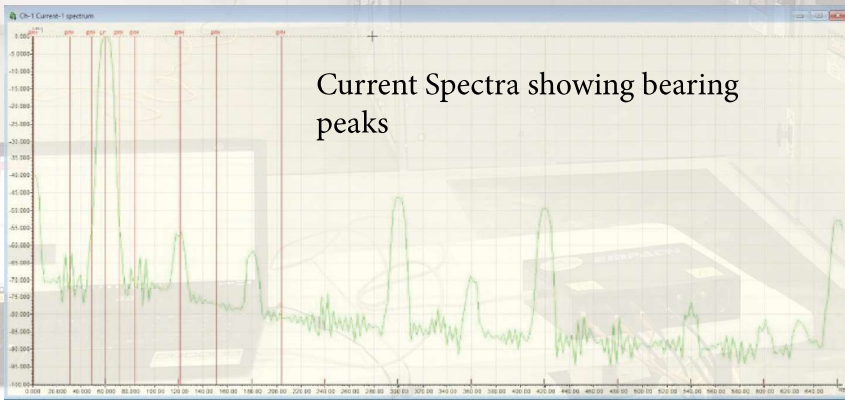
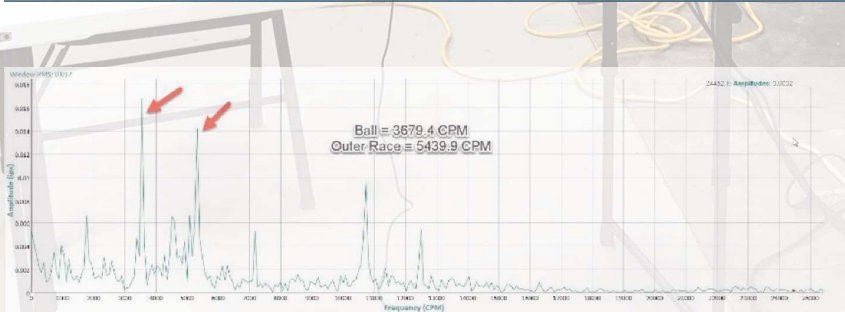
Results	Time	Freq.	Bearings	Phasors	Extras
Power factor			OK		
Current			OK		
Voltage			OK		
Load			Exceeds Nm Plt. [Ld 128.7%]		
Vlt-GND ref.NDT neutral			OK		
Connection			OK		
Rotor			OK (C:1)		
Stator (mechanical)			OK		
Air gap			OK		
Harmonic distortion			OK		
Misalignment/Unbalance			OK		
Bearing/Unidentified			Prot'd Brng.		
Bottom line			Abnormal indications

EMPATH Auto-Fault Detection

*Note: Noise floor is -80 db

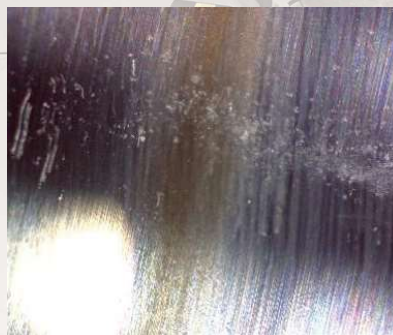
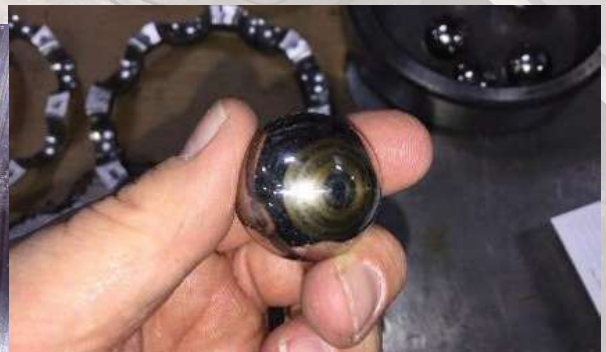
Data collected from the MCC in a 48 second collection. As soon as the data was collected, the findings show in the EMPATH Auto-Fault Detection. Vibration was used to confirm the bearing conditions before removing the motor for repair. Stage 2 bearing fault detected
