## Case Study Slightly Loose Bearing Fits and VFD Issues in Vertical Motor with EMPATH Electrical Signature Analysis

Howard W Penrose, Ph.D., CMRP  
President, MotorDoc® LLC

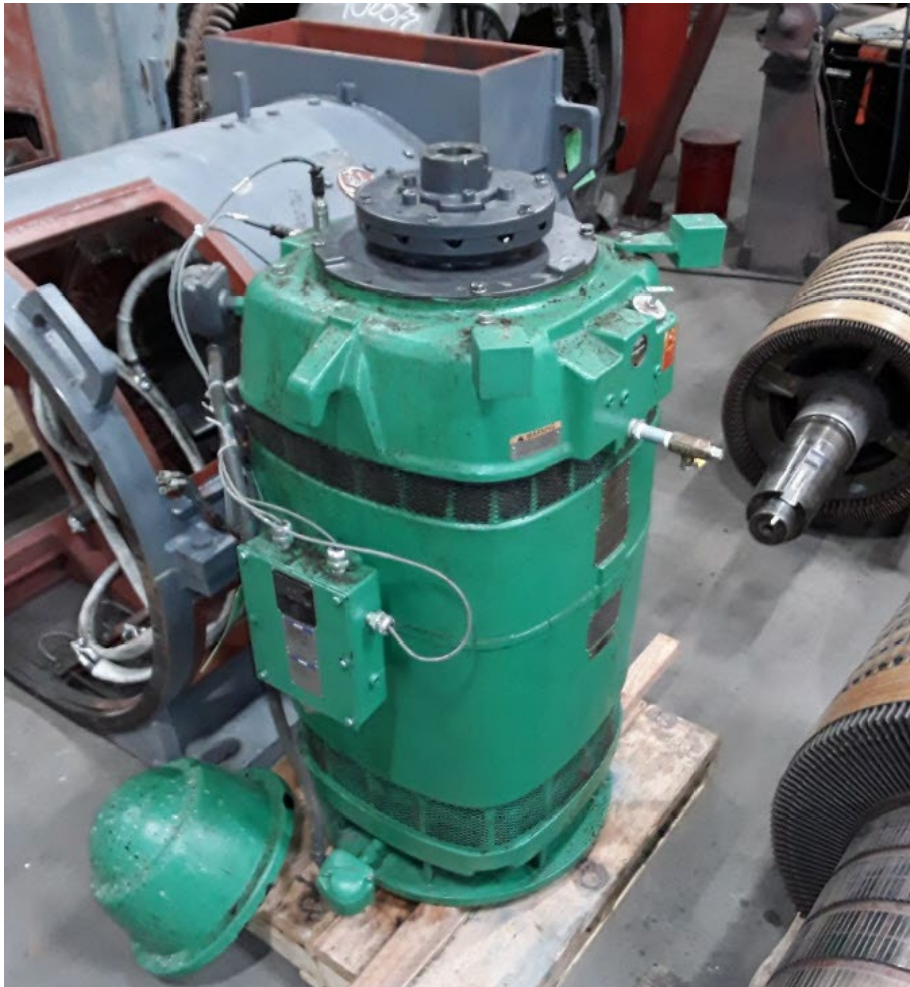
In-place testing was performed on a 350 horsepower, 460 Vac, 1780 RPM vertical motor (Figure 1) and EMPATH detected conditions associated with bearings, rotor and early winding stress were indicated. The motor was removed for routine overhaul and the defects were investigated.

*Figure 1: 350 horsepower electric motor prior to disassembly.*

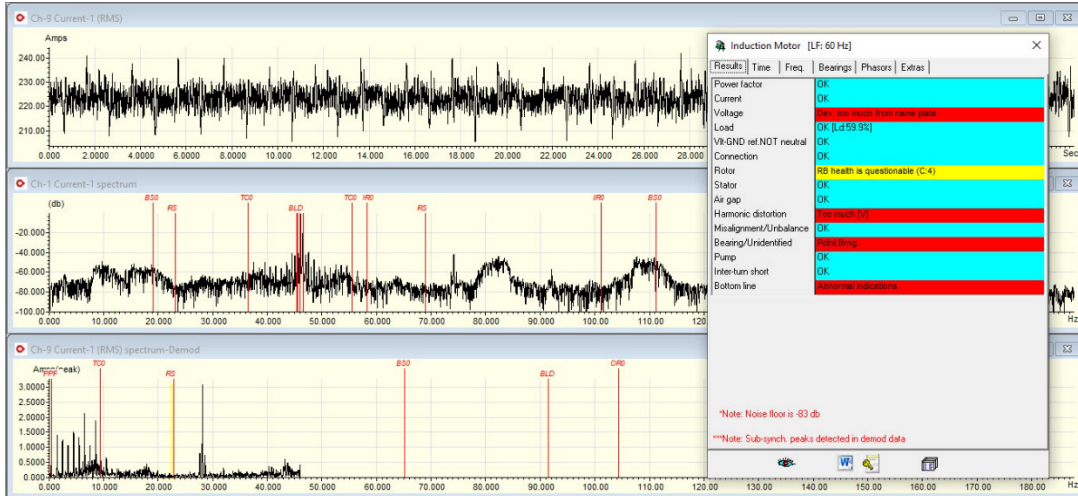
- Drive end bearing defects.
- Loose fits on journals, journals have ceramic insulation.
- Windings intact, but dirt and prior repairs result in winding stress and partial discharge. These also indicate incorrect VFD settings.

Figure 2: Automated fault detection of EMPATH ESA.

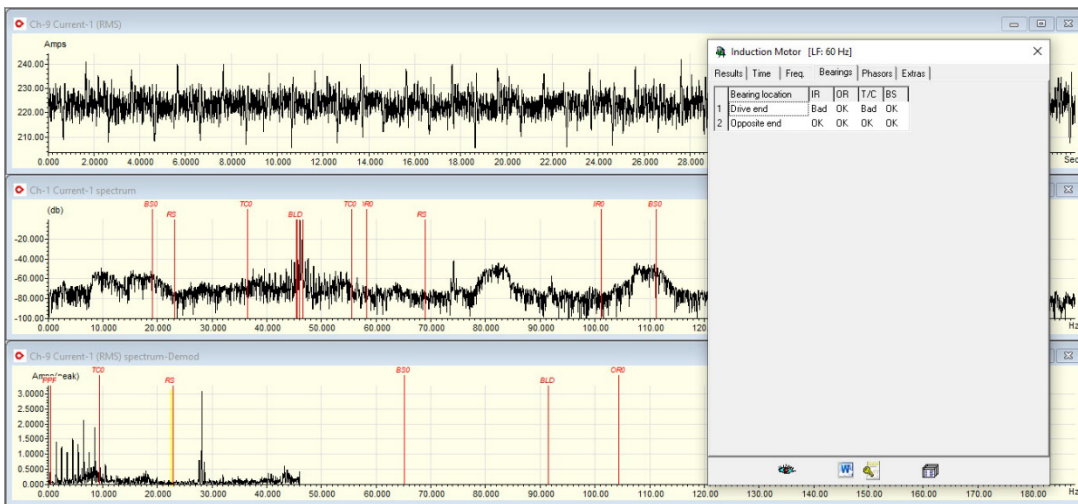
Figure 3: EMPATH detection of bearing components.

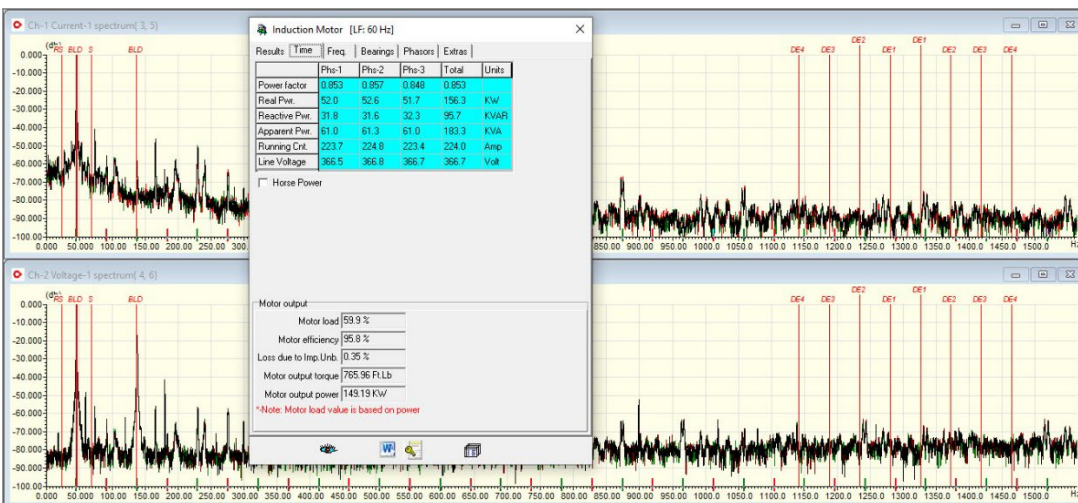
Figure 4: Low level dynamic eccentricity due to loose fits and rotor condition.

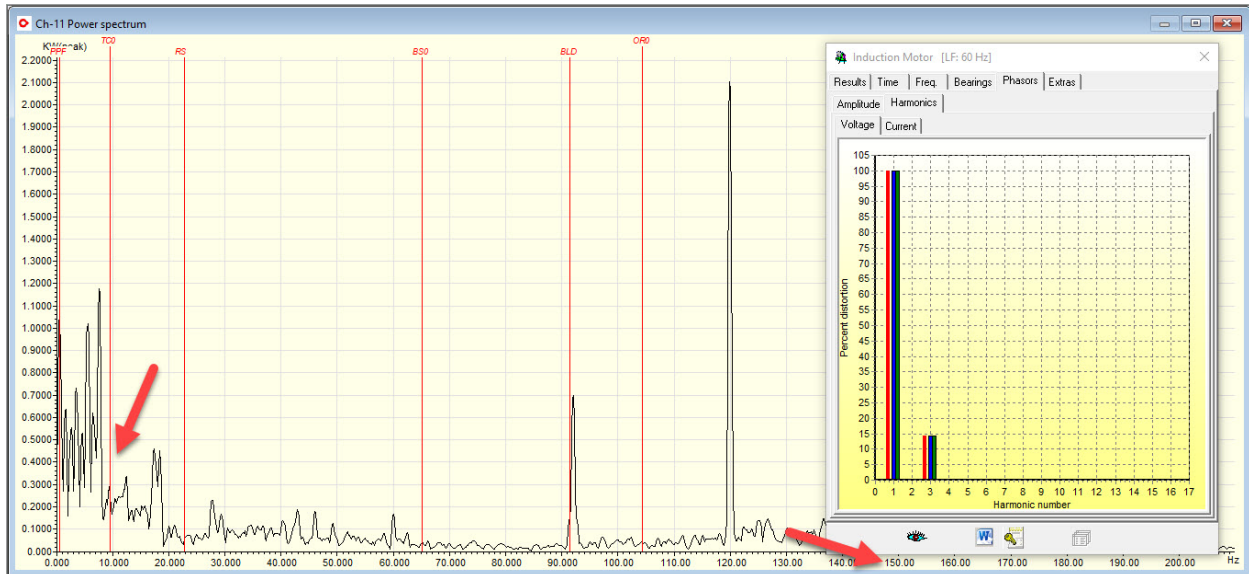
Figure 5: Excluding impellor rubbing (peaks on the left), bearings, loose fits, dynamic eccentricity, and winding stress losses are at least 4.35 kilowatts.

At the time of testing the motor was operating at an input of 156.3 kilowatts which means that the losses represent 2.8% of the load. This represents early detection and 38,110 kWh per year with the projected emissions at a minimum of 27 metric tonnes CO<sub>2</sub>. Following are the post disassembly findings for the bearings.

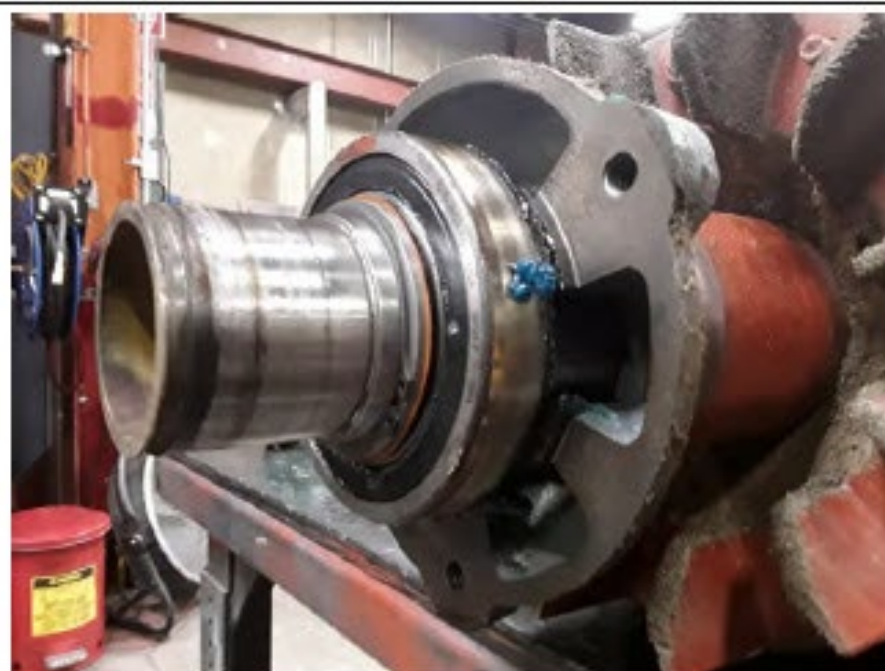
Figure 6: Drive end bearing - partial disassembly.

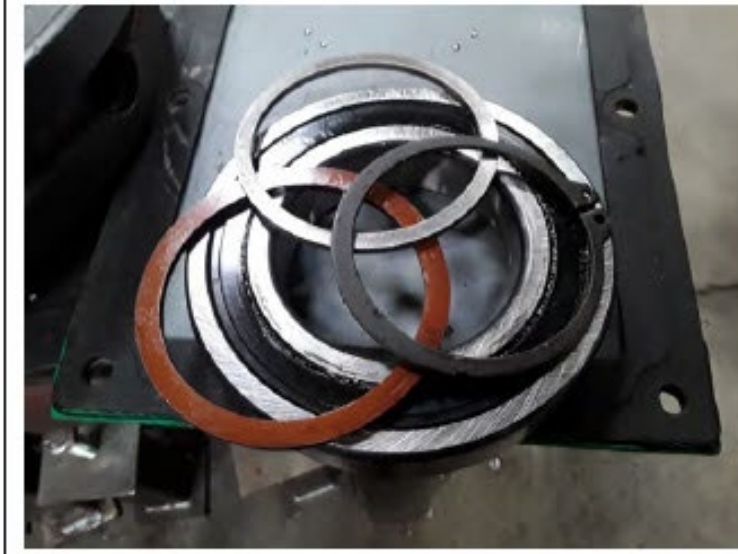
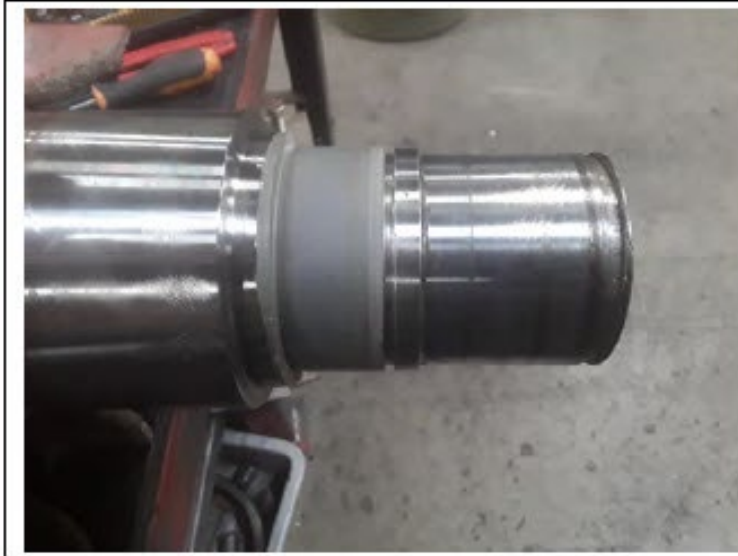
Figure 7: Removed bearing and bearing journal with ceramic.
