Transformer Analysis and Case Studies with Electrical Signature Analysis Part 1

Howard W Penrose, Ph.D., CMRP President, MotorDoc[®] LLC Lombard, Illinois info@motordoc.com

II. Case Study 1: Lighting Panel Energy Study

III. Windpower Transformer Resonance and SSR

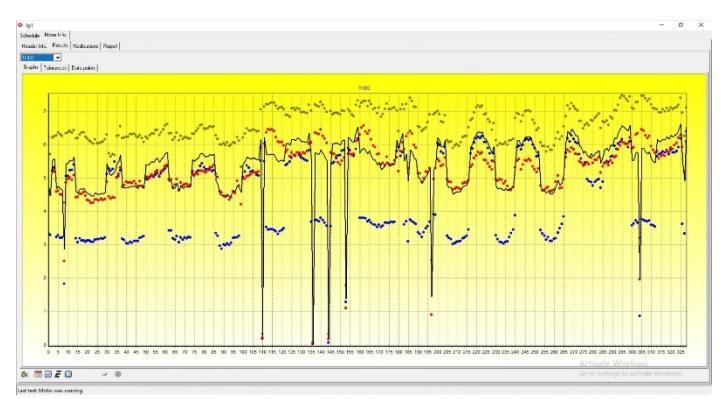
An ECMS-1 continuous monitoring system was connected to a 480 Vac, 3-phase with neutral, 125 Amp-rated electrical panel directly fed from three single phase polemounted transformers. The circuit is divided into a balanced 277 Vac lighting system with an expected maximum load of 20 Amps per phase. An Onics neutral harmonics filter is attached to the circuit to reduce harmonic-based losses in the neutral. The ECMS-1 is included in the circuit for continuous monitoring and energy monitoring for the study. Two weeks into continuous monitoring it was noted that under specific loading conditions the monitoring system was identifying a loose connection in Phase 3 which prompted an investigation (Figures 2 and 3).

Figure 2: ECMS-1 continuous monitoring total harmonic distortion current

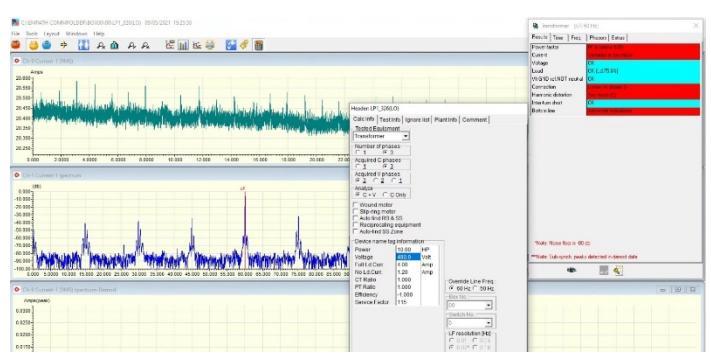
The EMPATH data collected by the ECMS-1 was evaluated as shown in Figures 4 and 5 which indicated a significant unbalance during those times. As shown in Figure 5, the power factor is already low as it represents the 'True Power Factor,' which includes current harmonic distortion.

Figure 4: EMPATH analysis screens low frequency and RMS (in current)

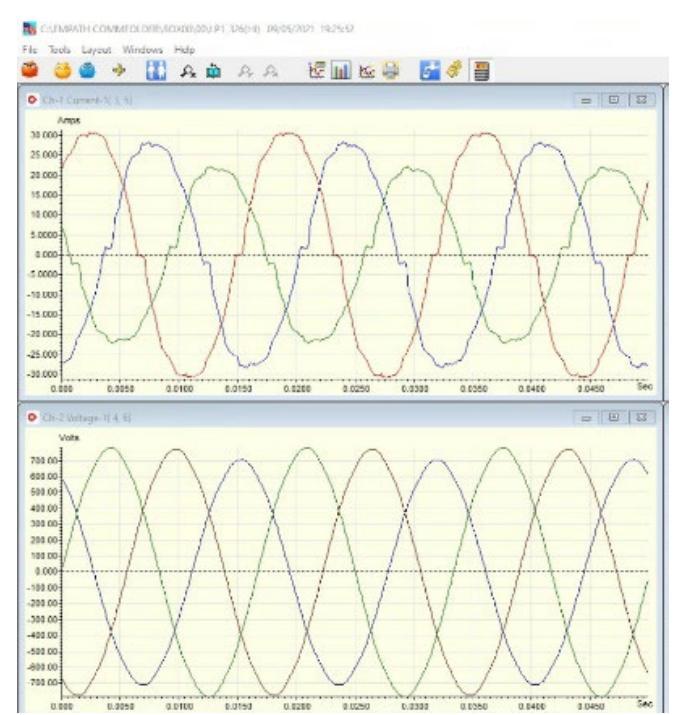
A review of the voltage and current waveforms in Figure 6 shows that Phase 3 is shifted and has a much lower peak to peak amplitude.

Figure 6: blue is Phase 1, red is Phase 2, and green is Phase 3, top is current in amps p-p and bottom is voltage p-p. Poor power factor results in a dramatically out of phase voltage and current.

The notching in current shown in Figure 6 is related to power harmonics and also an indicator of the sidebands noted around line frequency, harmonics and subharmonics as show in Figure 7. The subharmonics are in ¼ line frequency increments (15Hz, 30Hz, 45Hz) with sidebands of 0.536 Hz.

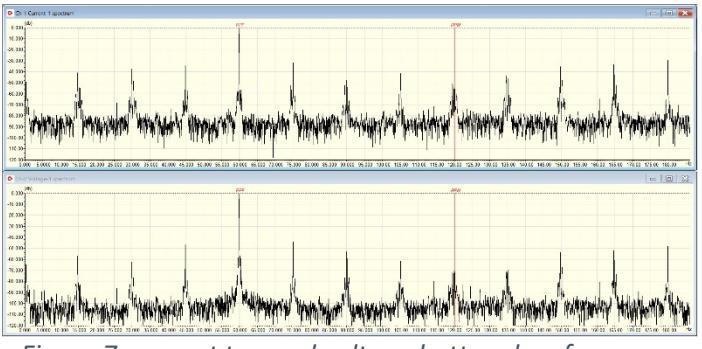
Figure 7: current top and voltage bottom low frequency data set. 15 Hz, 30 Hz, and 45Hz sub-harmonics.

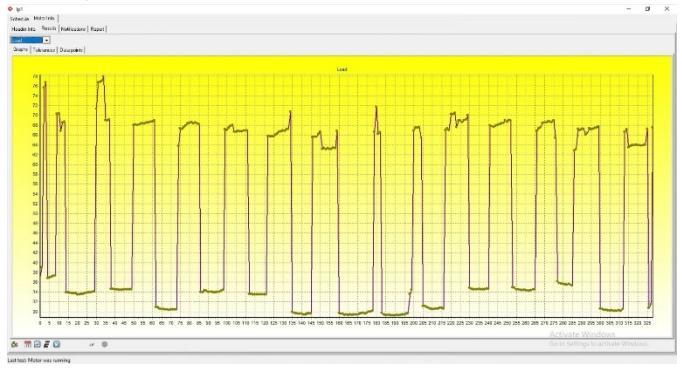
The loading was evaluated in Figure 8 and it was found that the 'loose connection' finding would appear under the heavier loads. A review of the current and voltage harmonics, as shown in Figure 9, indicate that Phase 2 and 3 have even harmonic content while Phase 1 is generally lower. It is also noted that even-numbered harmonics are present, an indicator of an issue within the transformer.

Figure 8: load profile in % of full load as set in the software header. Phase 3 issue shows during peak loads only.

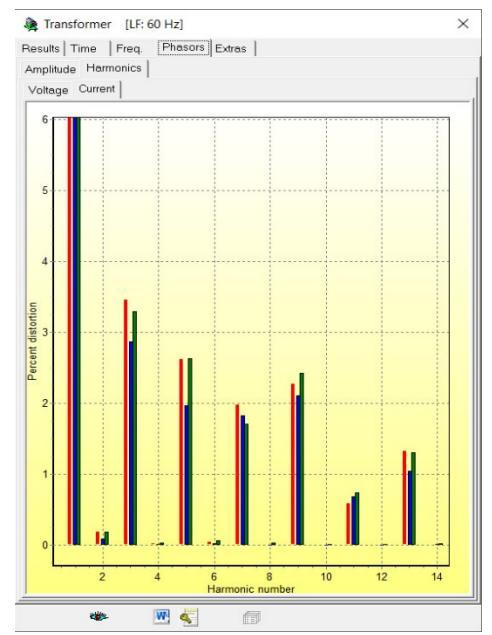
Figure 9: harmonic content. Phase 1 blue, Phase 2 red and Phase 3 green.

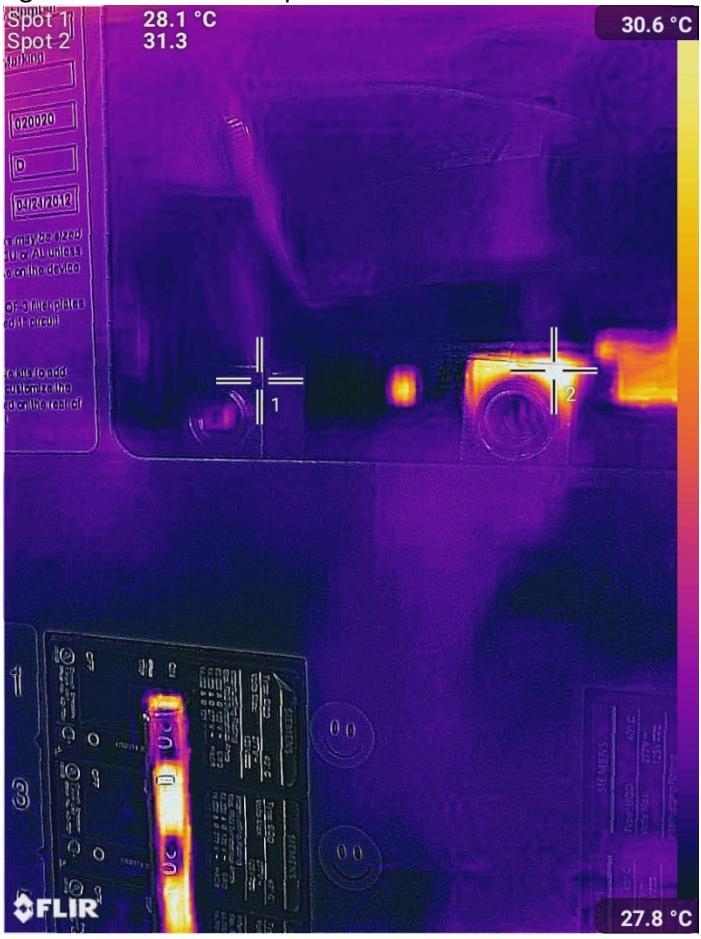
An infrared analysis was performed on the lighting panel to identify if a loose connection did exist at that point. As shown in Figure 10, a loose connection was detected and tightened with small improvement to the data collected.

Figure 10: 3C hotspot found at the top of one lug. Lug tightened and unbalance dropped to 1C.

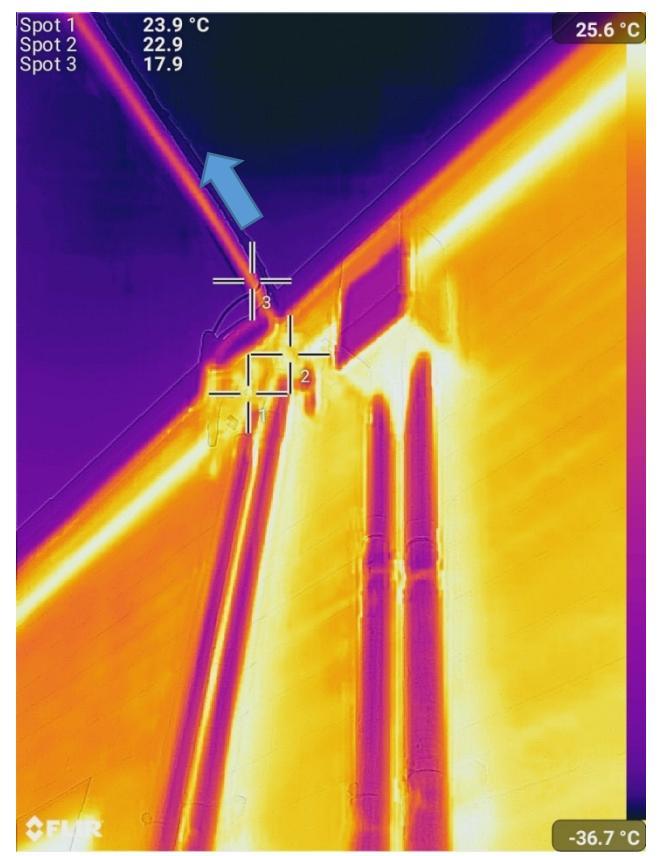
Figure 11: IR of line coming to the outside disconnect of the facility.

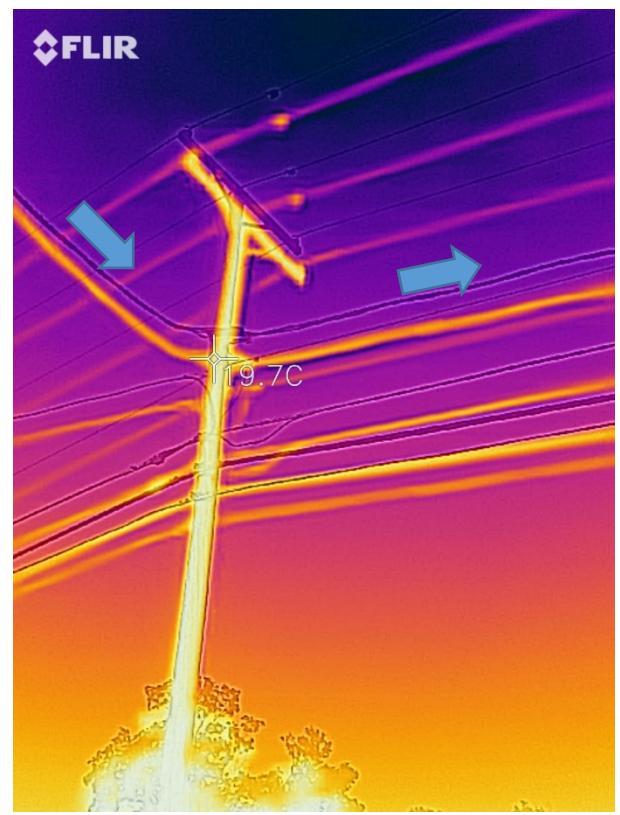
Figure 12: originally expected the cable to go left instead of right.

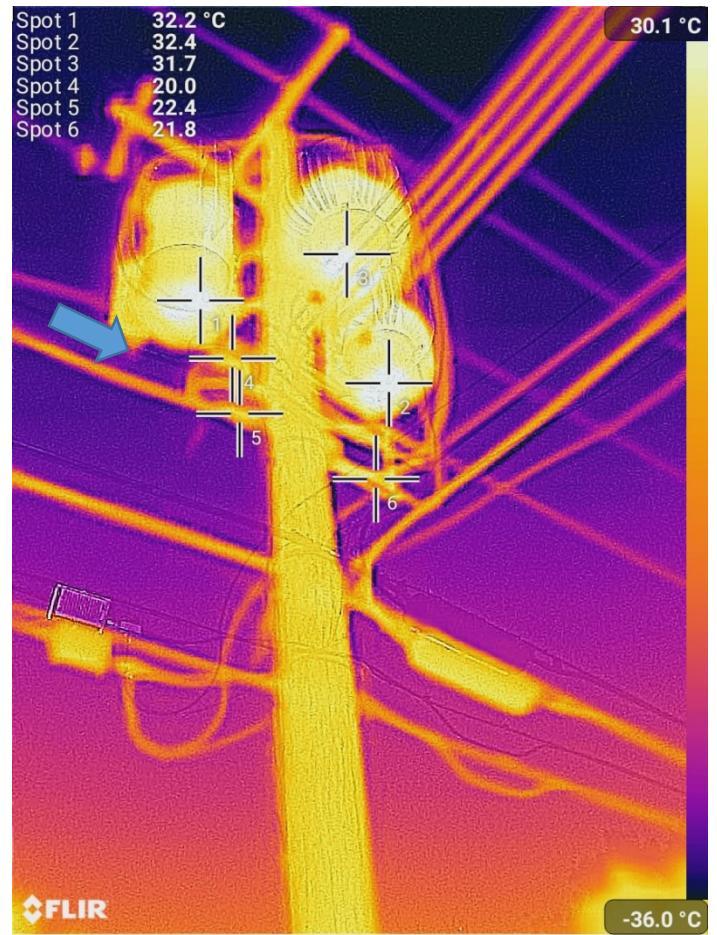
Figure 13: Blue arrow is parallel to feeder towards pole mount transformers.

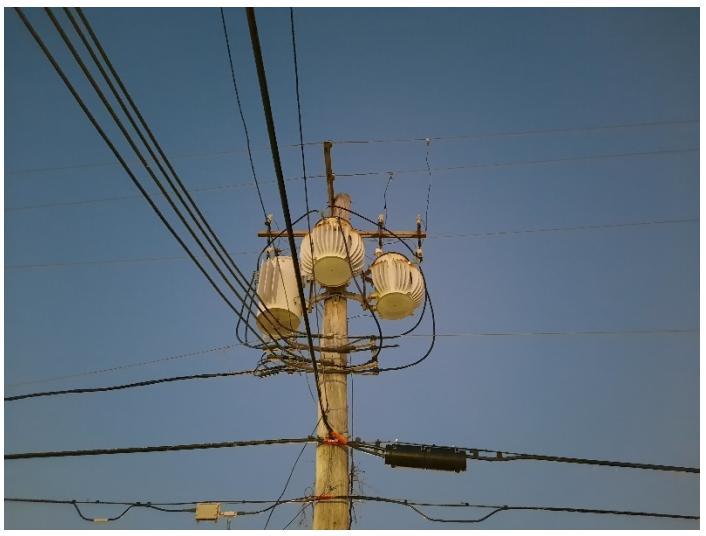
Figure 14: pole mount transformers. The one on the left is Phase 3, middle is Phase 2 and right is Phase 1. Different transformers and resulting unbalanced circuit impedance plus possible loading at the neighboring facility.

As noted in Figure 14, there are two of one design transformer and Phase 3 is a different design transformer. It can be assumed until additional information is forthcoming from the utility that they are different designs and impedances. The neighboring facility has additional 12 roof-top air conditioning units and is three times the size and related lighting as the facility being monitored. However, their operating hours are dramatically different, primarily being weekend afternoons and evenings and limited weekday evenings. Their operating hours and the findings did not coincide indicating that the balance issue is most likely related to the circuit impedance from mismatched transformers.

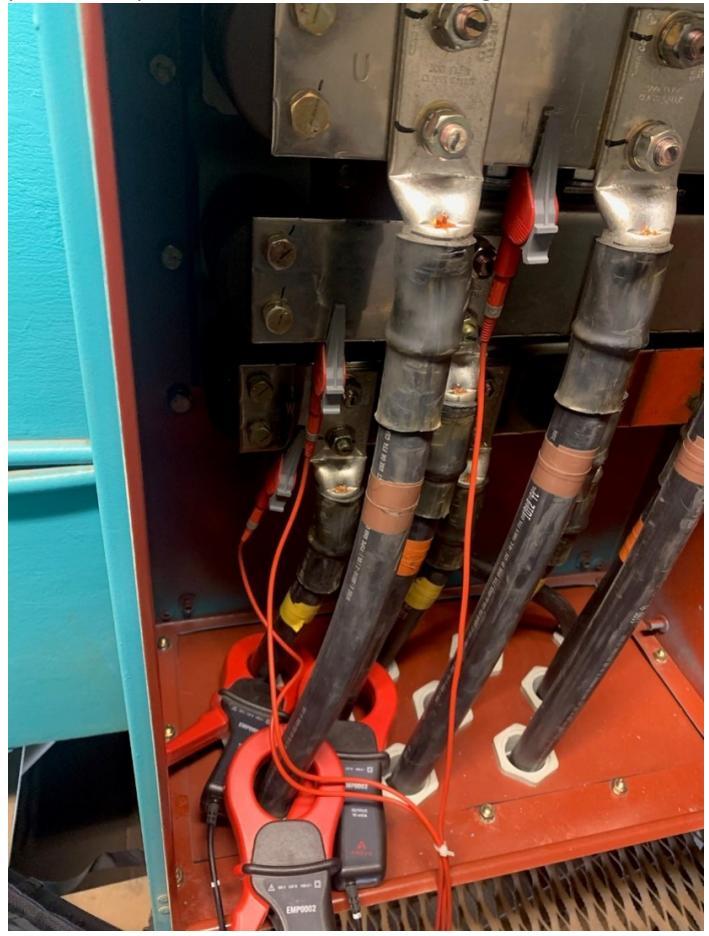
Figure 15: Voltage and current connections at generator. CT ratio used is 3:1 with one clamp around 1/3rd of cables per phase.

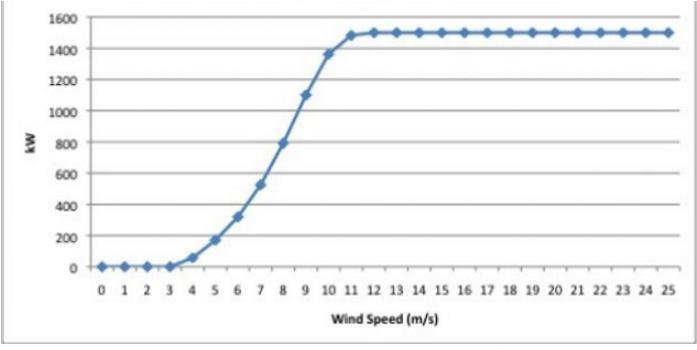
Figure 16: during study wind was 5.8m/s with gusts to 8m/s at 13C.

The wind speed was noted, as shown in Figure 16, to understand the operating point on the power curve. It was also noted that there were frequent gusts and the wind direction changed rapidly which we expected would cause additional oscillation.

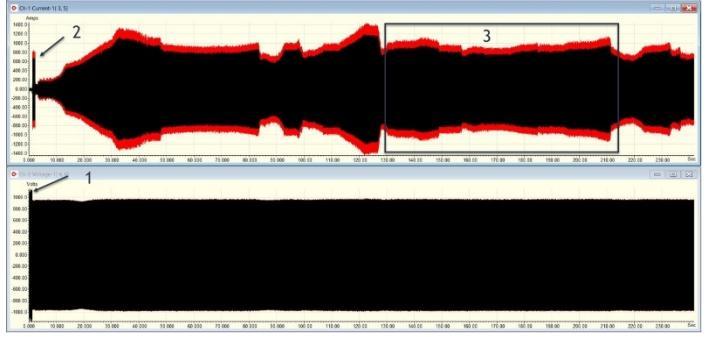
Figure 17: startup with voltage present (1), breaker closed when wind speed and blade speed were acceptable to the turbine software (2), and a point of low oscillation (3).

It is noted in Figures 17 and 18 at point (5) that the center of the peaks is 2880 Hz with two times line frequency sidebands. Items (3) and (4) are the firing frequency of the rotor inverter (3) and it's harmonic (4). In a well set up turbine at heavier loads and with less capacitance due to long distance transmission lines, the resonance (5) will have much lower peaks.

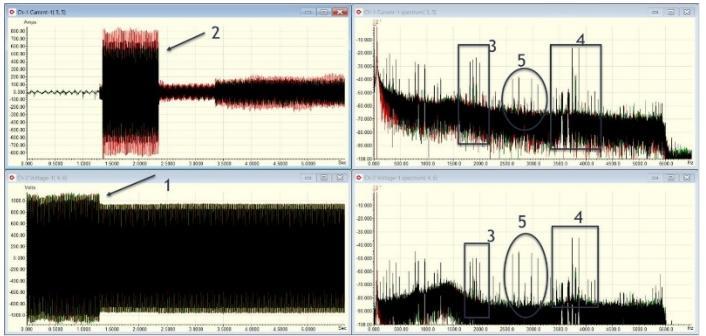
Figure 18: close up of when the circuit closes and the impact on frequencies shown. Transformer resonance (5) and tank circuit rotor inverter frequency with 2nd harmonic (3), (4).

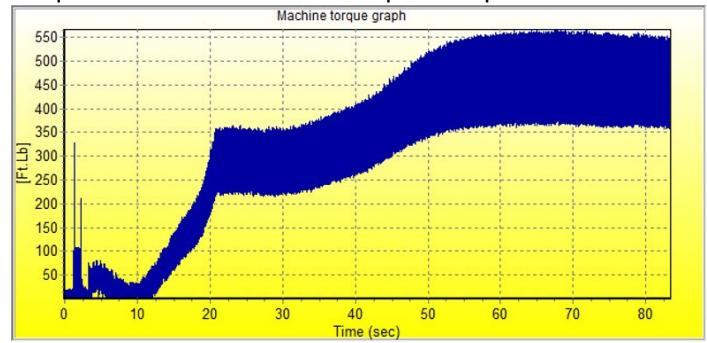
The airgap torque resulting from this starting process is outlined in Figure 19. In this case it is noted that there is a significant initial torsional impulse followed by a valley and then the airgap torque increases. Of particular interest is the increasing oscillation (peak to peak) of the air gap torque as the machine comes up to full power.

Figure 19: air gap torque as wind turbine comes up to load.

This oscillation occurs at 24 Hz and 48 Hz as predicted by Mohammadpour and Santi for SSTI and SSCI.⁶ While relatively low, the torsional impulses at speed have a longterm impact on the powertrain, in particular the gearbox gears and bearings, and the rotor circuit.

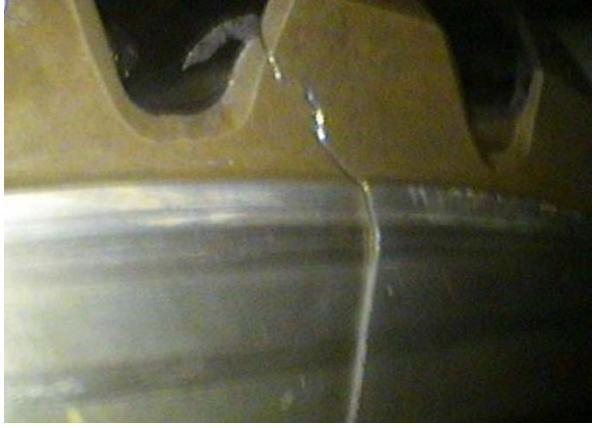
Figure 20: high speed wind turbine gear fracture.

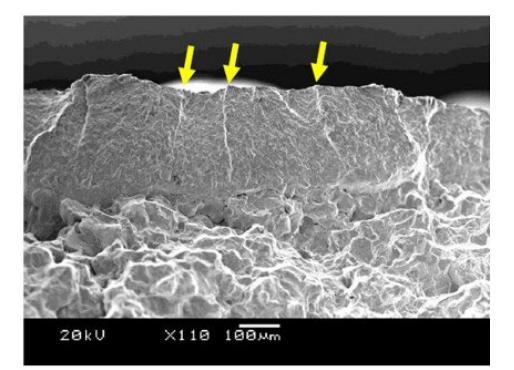
Figure 21: fatigue fractures in wind generator rotor wye ring prior to failure
