Evaluation of Asynchronous Wind Generator Stator Magnetic Slot Wedge and Coil Movement Using Electrical Signature Analysis

Howard W Penrose, Ph.D., CMRP
 President
 MotorDoc LLC
 Lombard, Illinois, USA
 hpenrose@motordocllc.com

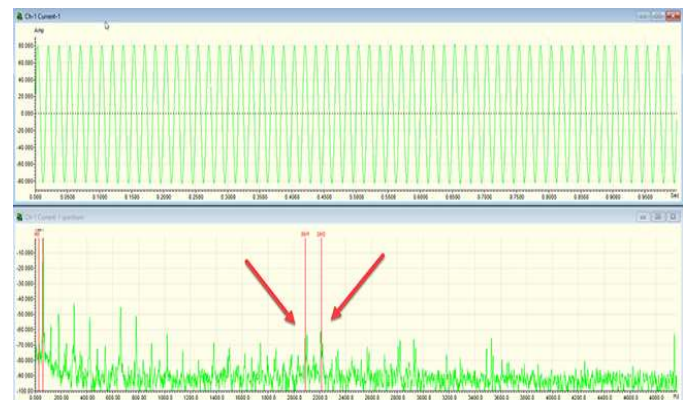
Fig. 4. Wedge signature in an 800 hp induction motor

or missing wedges based upon (3) would be 2091.14 Hz and 2211.14 Hz which were identified as shown in Fig. 4.

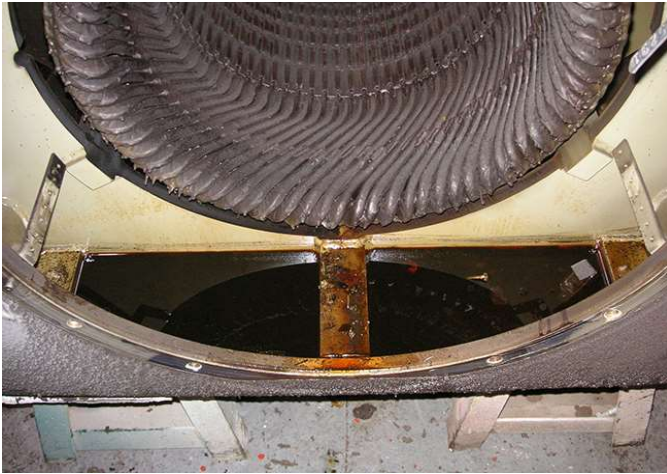
Fig. 5. 800 hp induction motor stator with no missing wedges

The electric motor subsequently failed shortly after data collection and was disassembled to identify fractures in the stator insulation where the coils exited the slots, which is also where one coil failed to ground. There were also general findings of end-coil movement and the stator wedges appeared to be intact (Fig. 5). Testing of seven identical electric machines in the same application were performed with similar ESA findings related to the stator slot frequencies. Further investigation discovered that the surge rings were not laced to the stator bracing and each stator was repaired following a second identical failure.

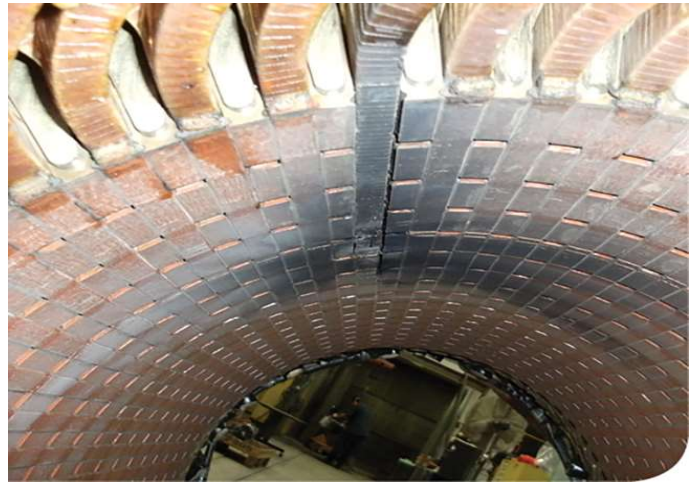
Fig. 7. Stator of DFIG missing wedges and failure point

Prior to removal of a 3MW, 4-pole, Doubly-Fed Inverter Generator (DFIG) operating at 30.224 Hz (1813.44 RPM) an ESA was performed to evaluate detection of known missing magnetic wedges. The signature was found as Fig. 6 with the stator slot signatures at 1572.1 Hz and 1692.1 Hz. Additionally, a winding short signature was found which, as noted in literature, can relate to other conditions such as stator slot sparking. The winding failed to ground prior to removal and was disassembled as shown in Fig. 7.
