EMPATH Bearing Detection Case Study

Bearing and winding failures due to harmonic and ground conditions in the motor and circuit.

300 horsepower, 1765 RPM, 6318ZZ bearings
40 Rotor Bars, 48 Stator Slots

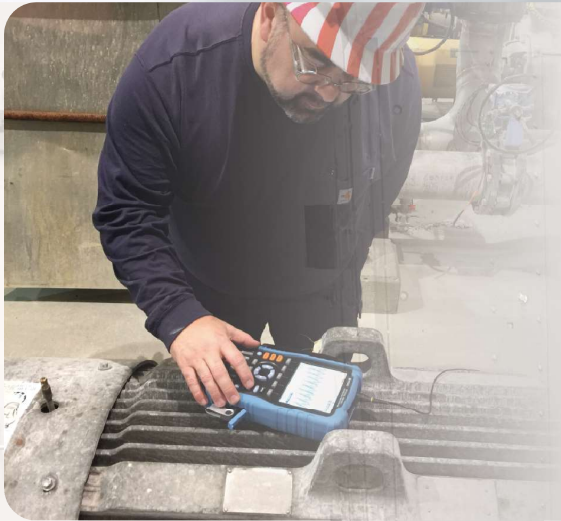
Data collected from the MCC in a 48 second collection. As soon as the data was collected, the findings show in the EMPATH Auto-Fault Detection. Vibration was used to confirm the bearing conditions before removing the motor for repair. Stage 2 bearing fault detected
